Re: Notice of Violation  
RCRA Compliance Evaluation Inspection  
EPA ID No: IN5 170 023 498

COMPLIANCE EVALUATION INSPECTION REPORT

**INSTALLATION NAME:** Crane Naval Surface Warfare Center

**DATE OF INSPECTION:** May 6-8, 2014

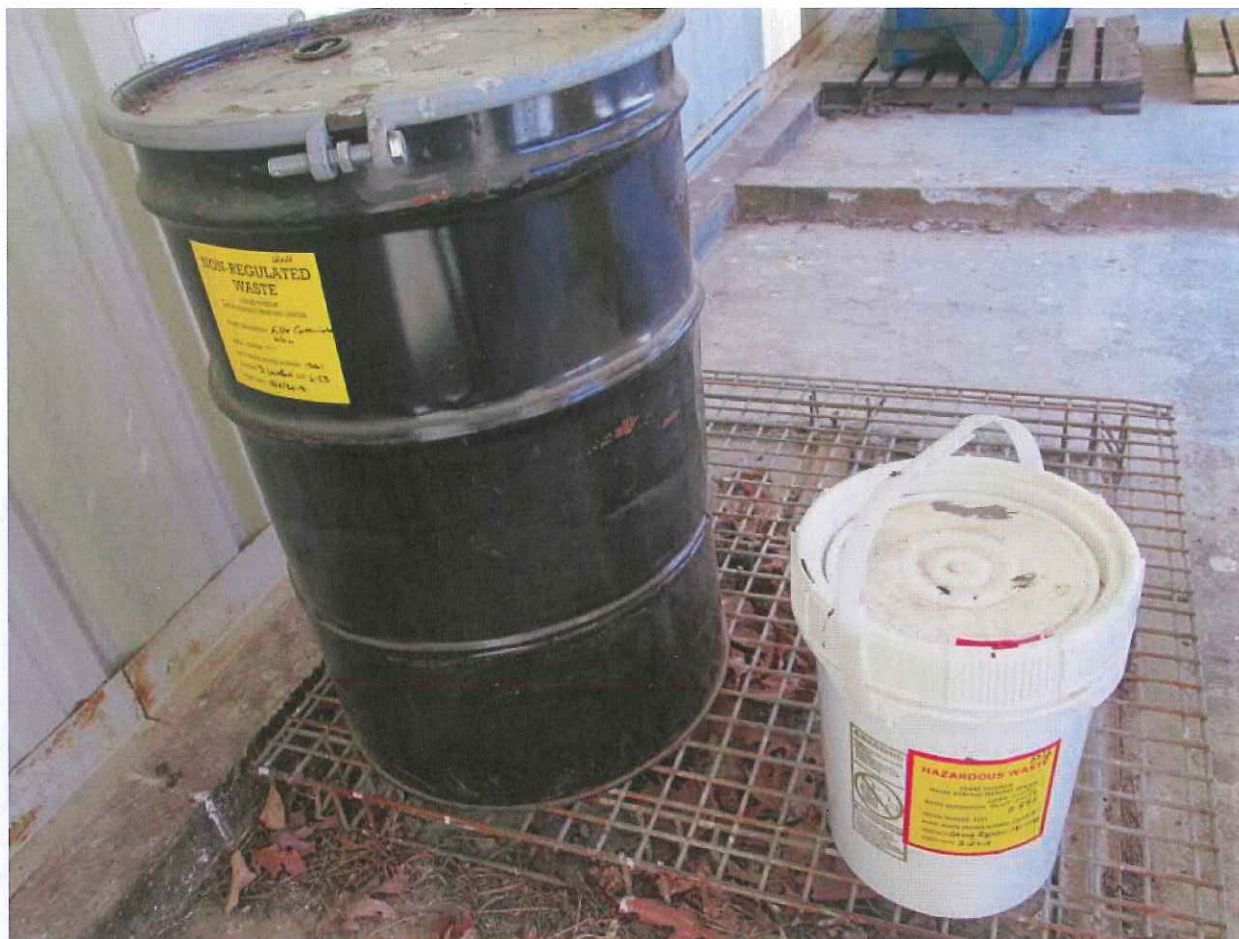
**PHOTOGRAPH #1**

- There were approximately twenty-seven hazardous waste containers in Sections H through M of the CSF multi-bay hazardous waste storage area (Photographs 1 through 7). All containers were closed/labeled.
- There were approximately eighty hazardous waste containers in Sections A through G of building 2993 (Photographs 8 through 17). All containers were closed/labeled.
- Exterior Lot Storage Area where hazardous waste solids were being stored, such as, grit blast residue, chromate waste, plastic glass, spent carbon zinc, ash, absorbent pads, plastic bead blast media, fiberglass, and sodium carbonate, universal waste activated/carbon ammonium nitric recovery (Photographs 18 through 19). All containers were labeled and closed. Adequate aisle space was being maintained at all above locations.

NAME OF PHOTOGRAPHER:	Sheila Burrus
DATE OF PHOTOGRAPH:	May 6, 2014
LOCATION OF PHOTOGRAPH:	Central Storage Facility/Section H
SCENE BEING PHOTOGRAPHED:	55-gallon container of filter/5-gallon container of lead
SITE LOCATION:	300 Highway 361 Crane, Indiana
INSTALLATION NAME:	Crane Naval Surface Warfare Center
INSTALLATION I.D. #	IN5 170 023 498

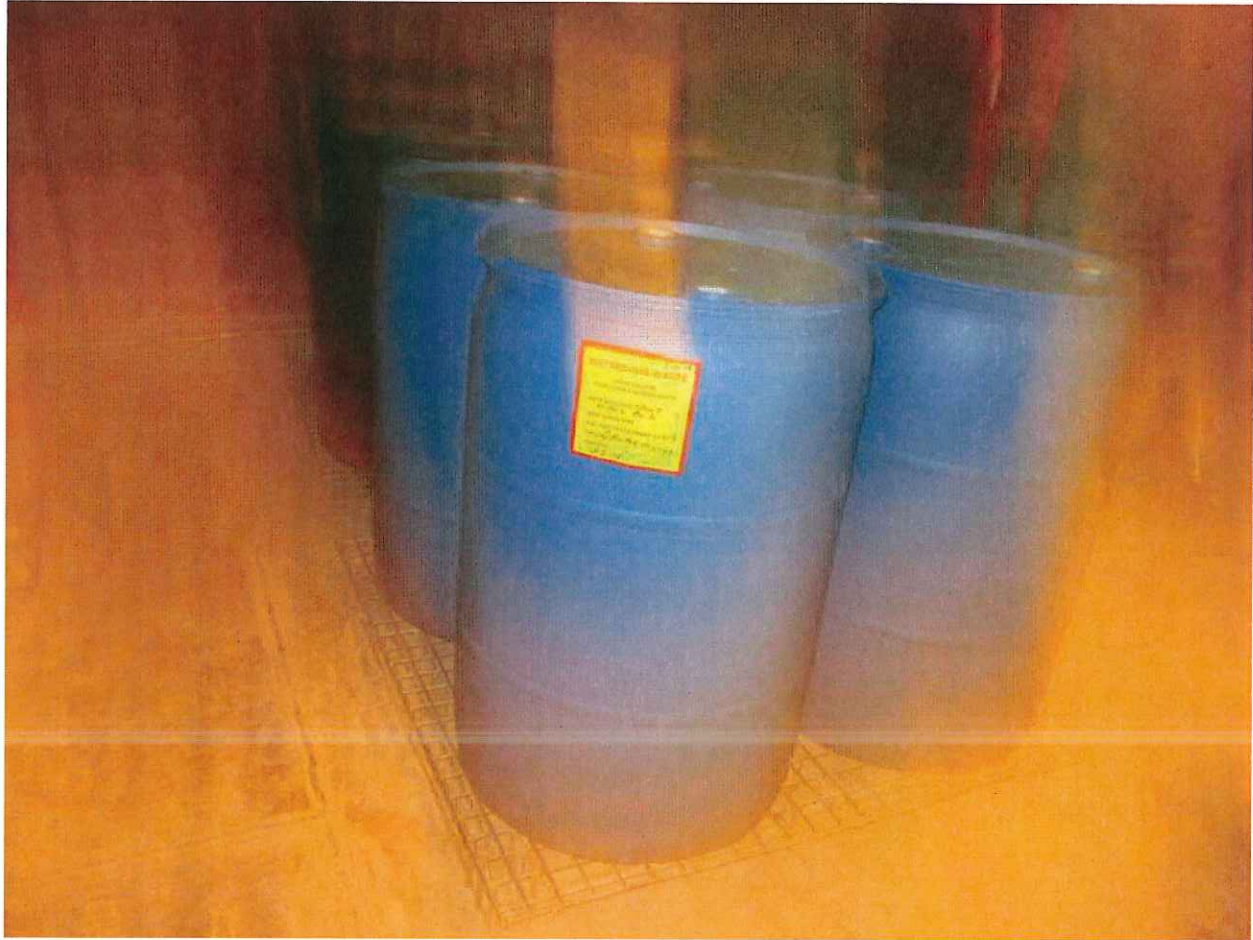
**PHOTOGRAPH #12**

<b>NAME OF PHOTOGRAPHER:</b>	Sheila Burrus
<b>DATE OF PHOTOGRAPH:</b>	May 6, 2014
<b>LOCATION OF PHOTOGRAPH:</b>	Building 2993 – Section B
<b>SCENE BEING PHOTOGRAPHED:</b>	55-gallon containers of corrosive waste
<b>SITE LOCATION:</b>	300 Highway 361 Crane, Indiana
<b>INSTALLATION NAME:</b>	Crane Naval Surface Warfare Center
<b>INSTALLATION I.D. #</b>	IN5 170 023 498

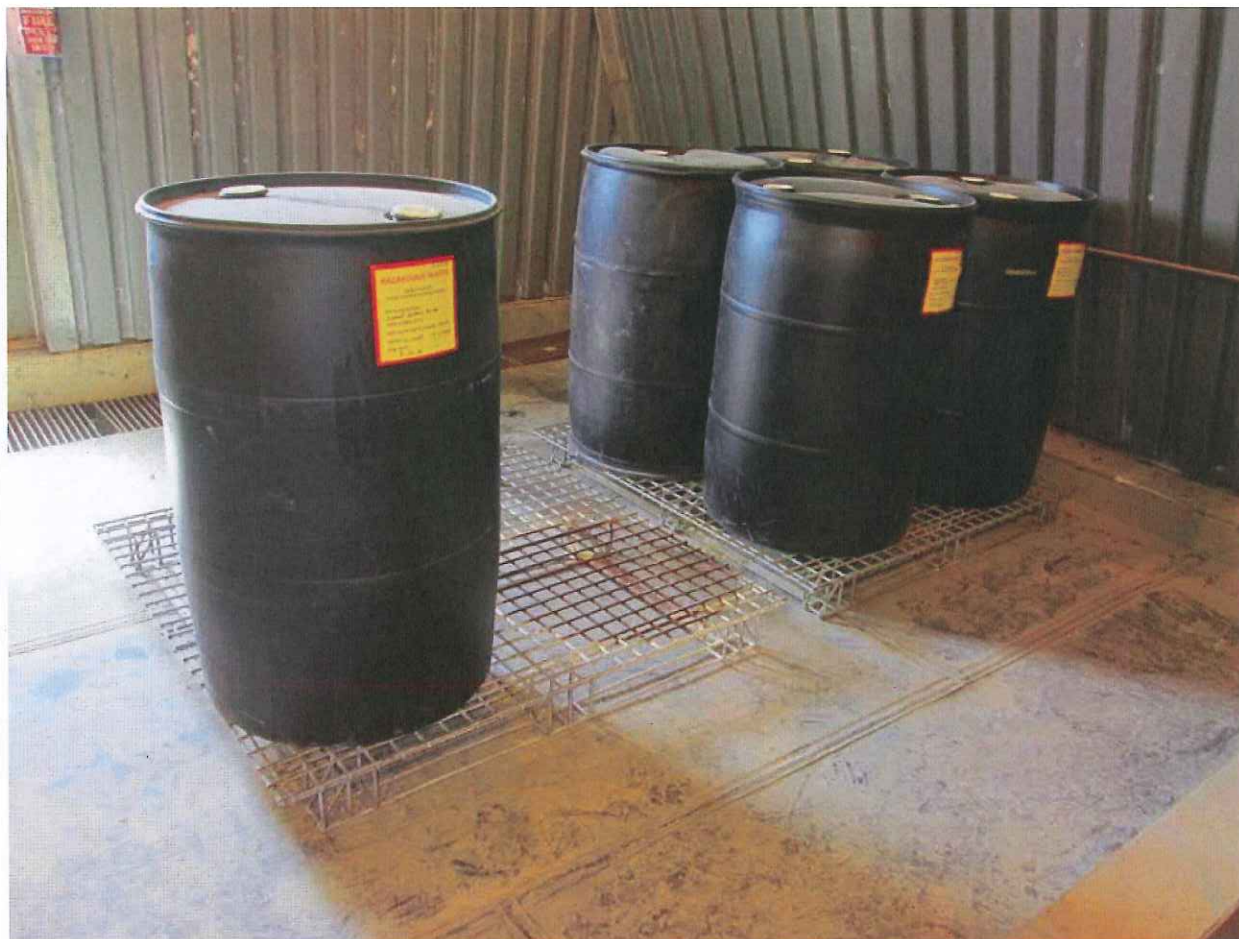
**PHOTOGRAPH #13**

55-gallon drums of corrosive waste

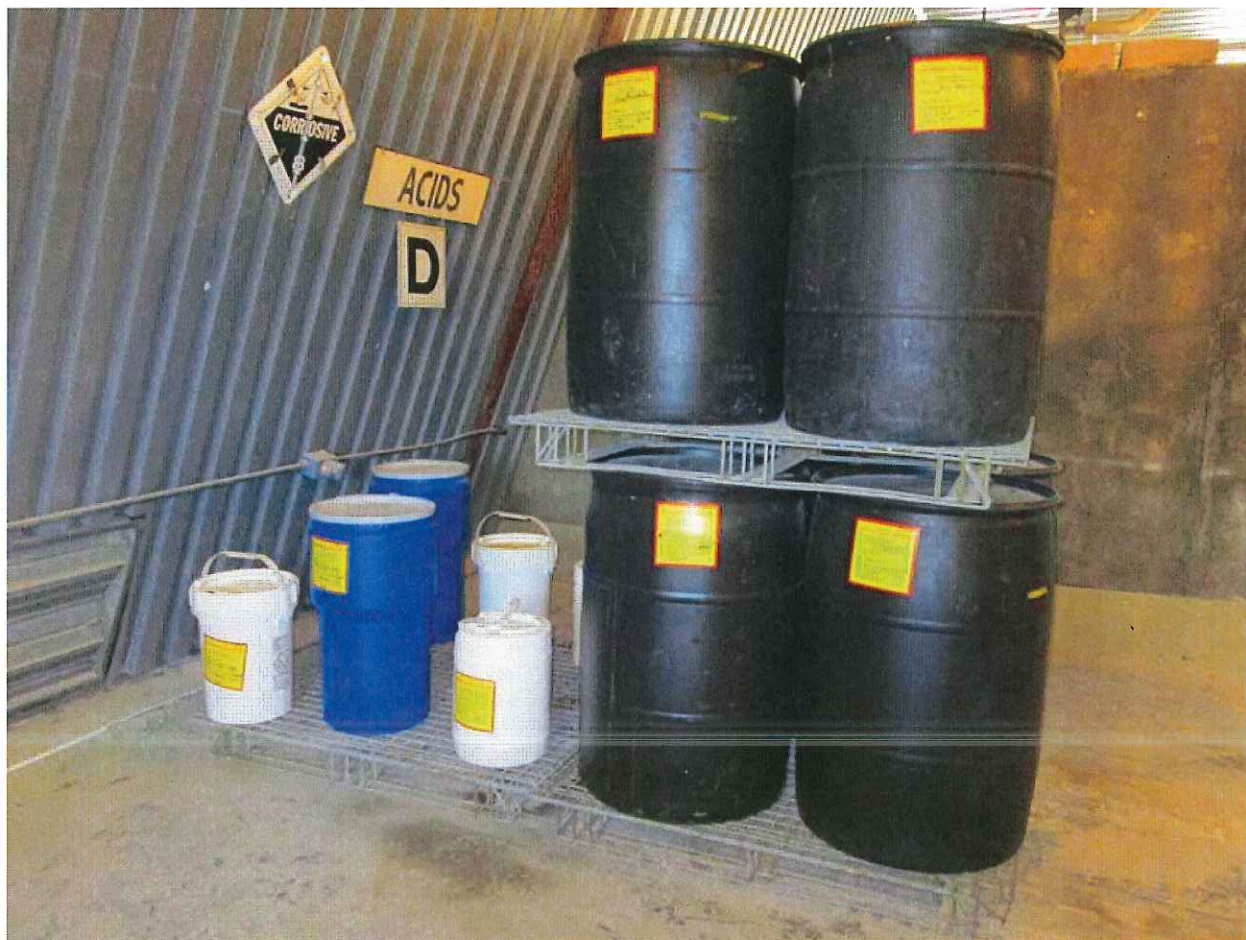
**PHOTOGRAPH #14**

containers of corrosive waste acids

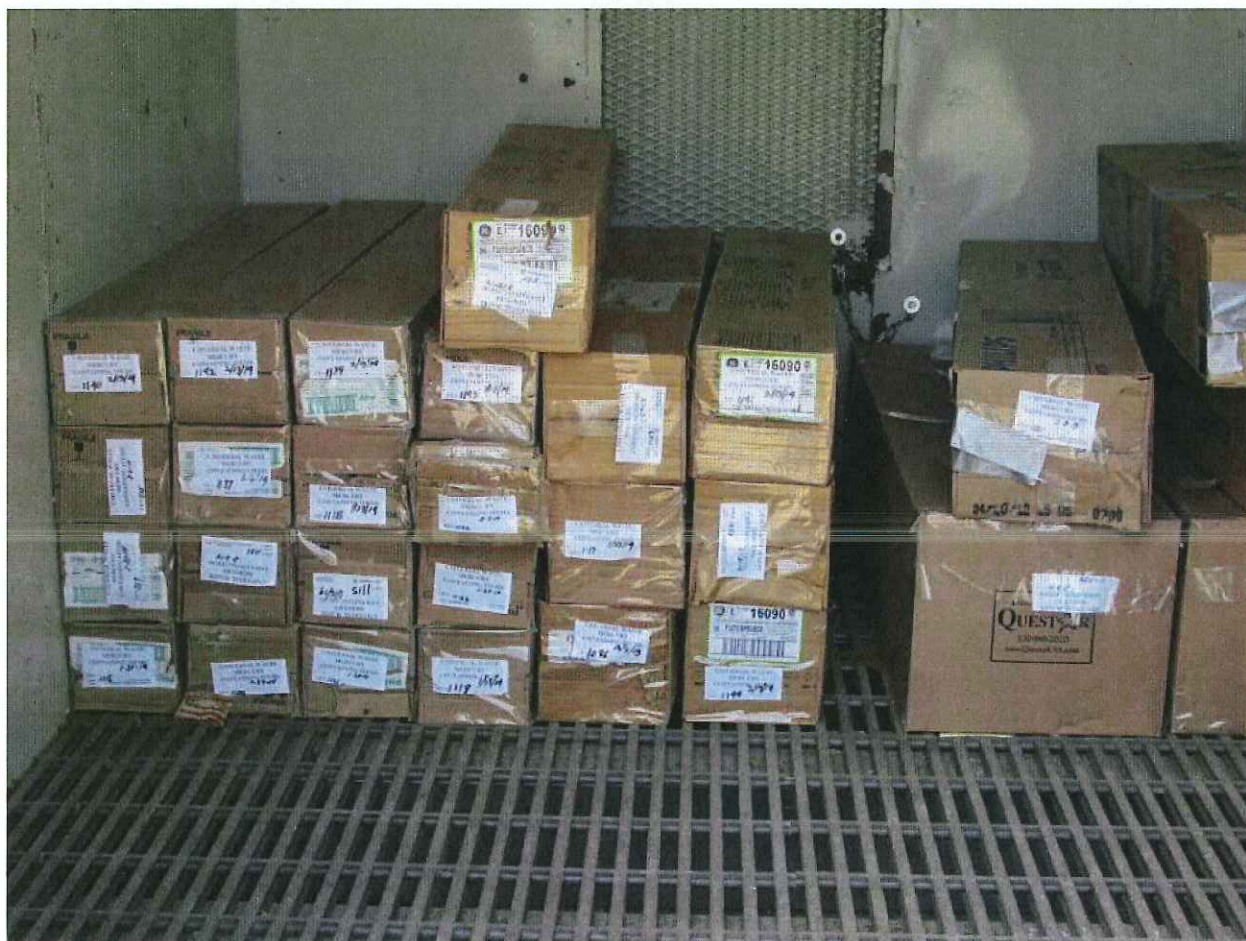
PHOTOGRAPH #20

- There were closed/labeled waste lamps being stored outdoors next to the exterior lot storage area (Photograph 20).

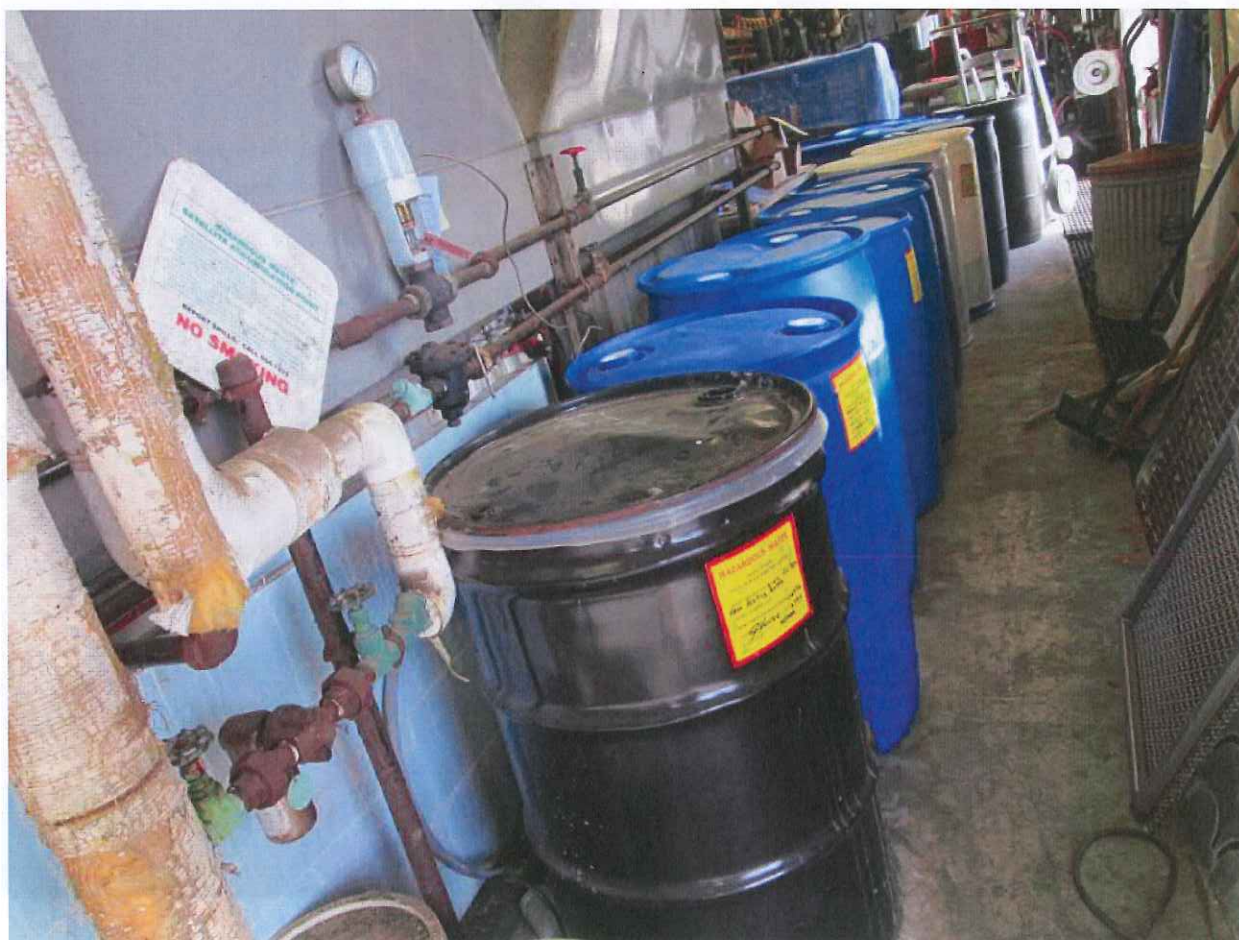
PHOTOGRAPH #21

- There were seven 55-gallon satellite accumulation drums of Aluminum Desmut Solution with a filled date of May 2, 2014 and five 55-gallon drums of spent hydrochloric acid with a filled date of May 5, 2014. The above waste was generated from a tank clean out. One 55-gallon drum of Aldokota Solution was dated May 5, 2014. One 55-gallon drum of zinc filters from the plating bath and one 5-gallon container of hydrochloric acid w/filter were also being stored. Weekly inspection were documented and conducted on May 2 and May 7, 2014 on the drums until transferred to the less than 90 day storage area on May 8, 2014 (Photographs 21 through 24).

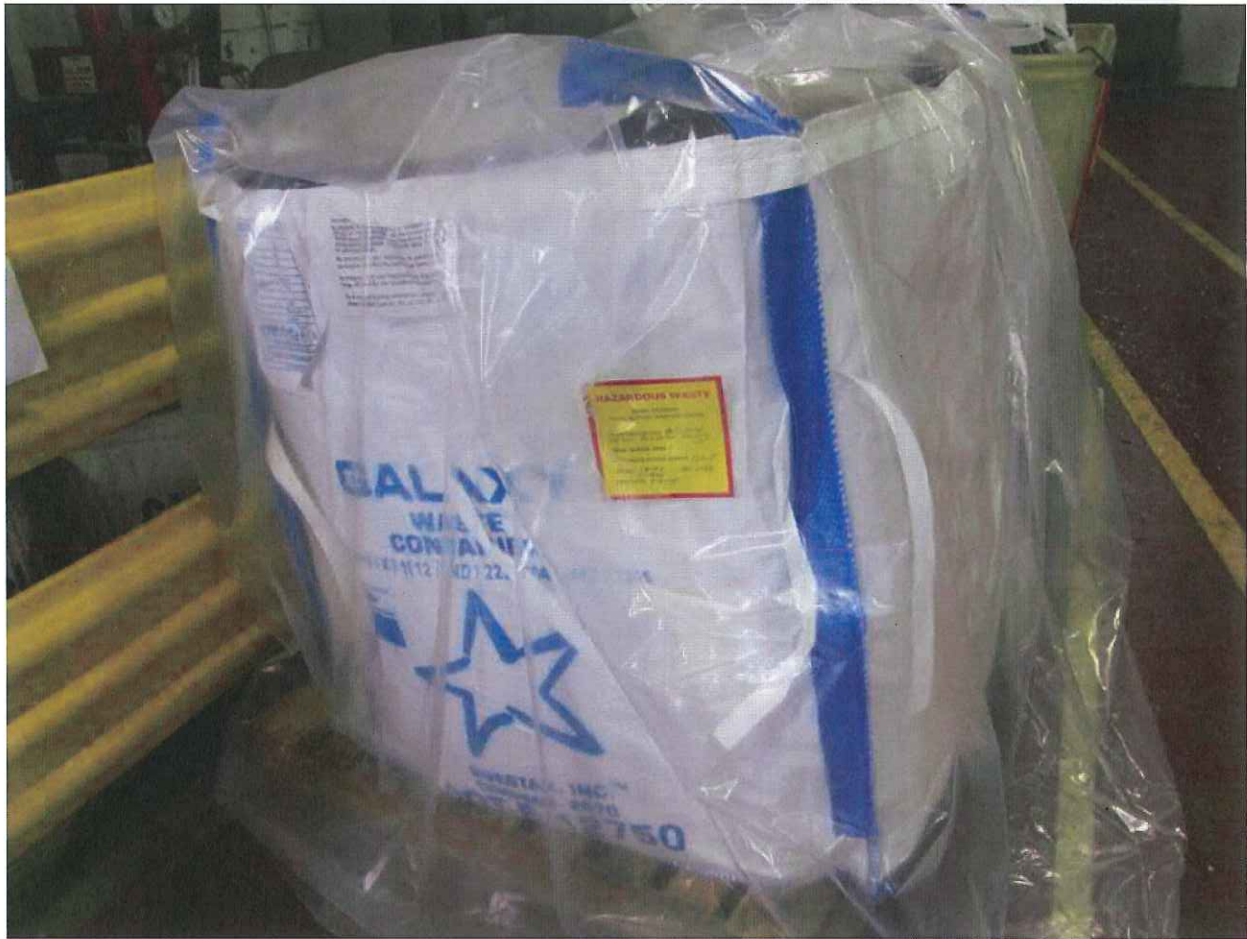
PHOTOGRAPH #25

NAME OF PHOTOGRAPHER:	Sheila Burrus
DATE OF PHOTOGRAPH:	May 7, 2014
LOCATION OF PHOTOGRAPH:	Building 105
SCENE BEING PHOTOGRAPHED:	one cubic yard tote of activated carbon
SITE LOCATION:	300 Highway 361 Crane, Indiana
INSTALLATION NAME:	Crane Naval Surface Warfare Center
INSTALLATION I.D. #	IN5 170 023 498

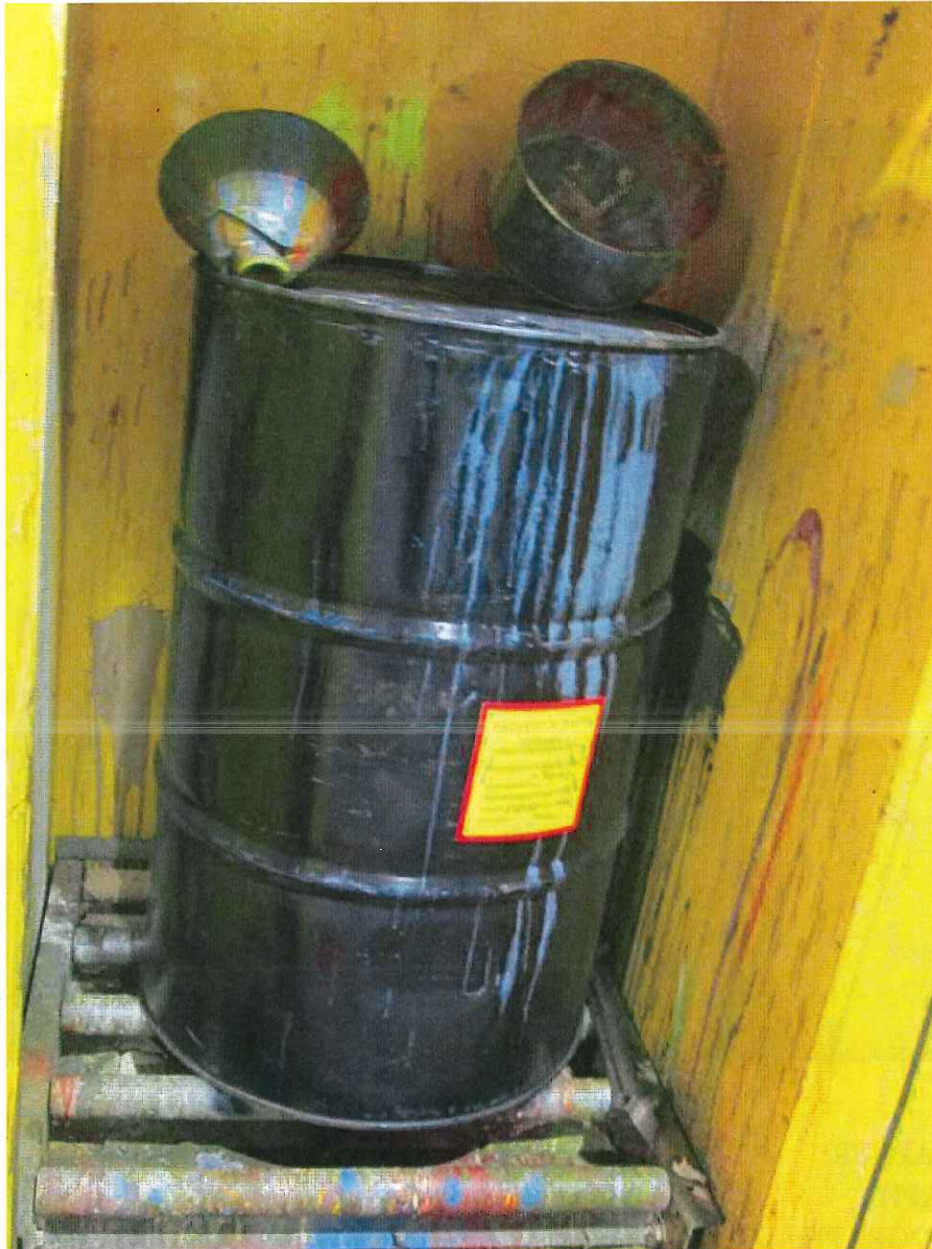
PHOTOGRAPH #26

NAME OF PHOTOGRAPHER:	Sheila Burrus
DATE OF PHOTOGRAPH:	May 7, 2014
LOCATION OF PHOTOGRAPH:	Building 104
SCENE BEING PHOTOGRAPHED:	55-gallon container of paint thinner
SITE LOCATION:	300 Highway 361 Crane, Indiana
INSTALLATION NAME:	Crane Naval Surface Warfare Center
INSTALLATION I.D. #	IN5 170 023 498

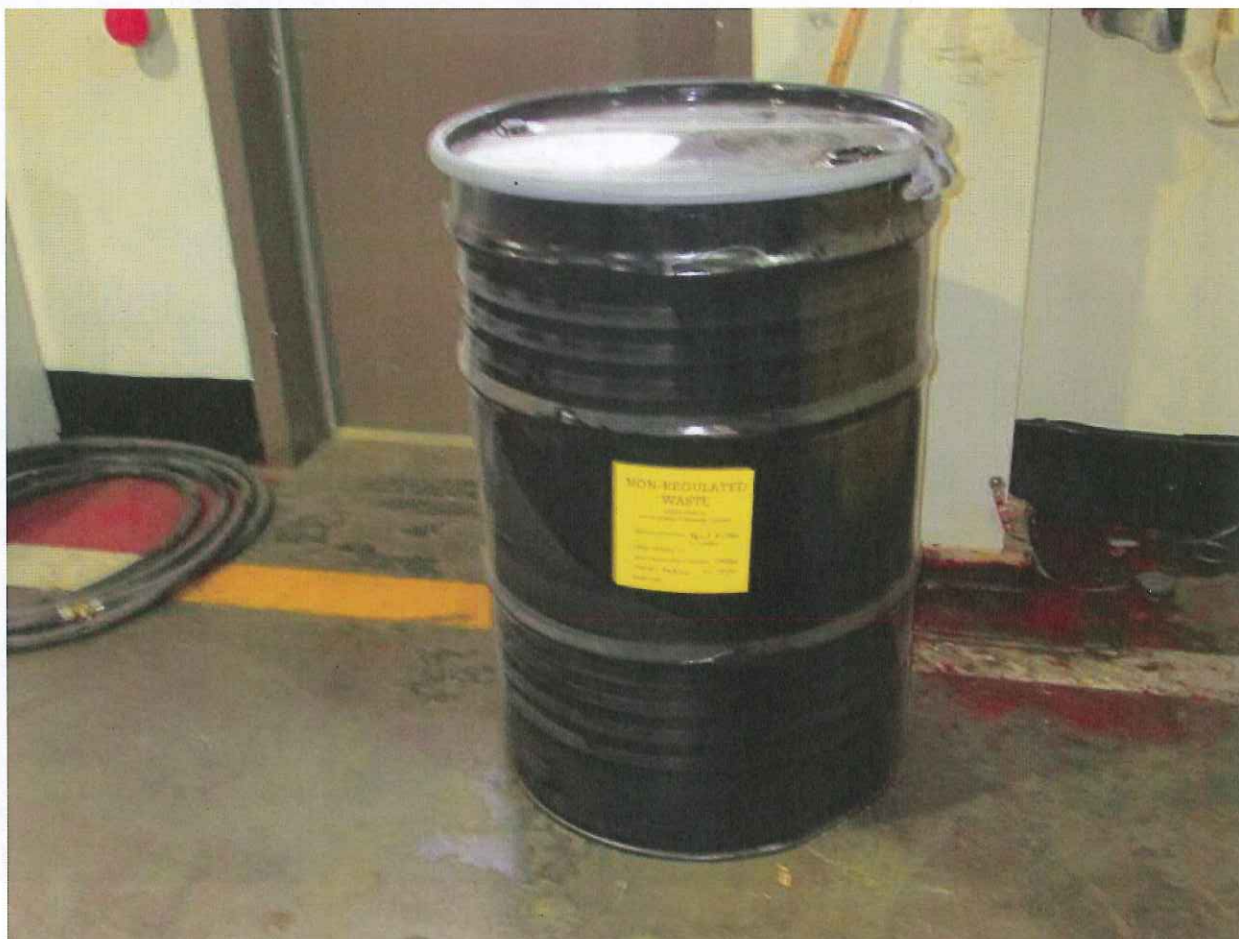
**PHOTOGRAPH #27**

<b>NAME OF PHOTOGRAPHER:</b>	Sheila Burrus
<b>DATE OF PHOTOGRAPH:</b>	May 7, 2014
<b>LOCATION OF PHOTOGRAPH:</b>	Building 104 (Abrasive Blasting)
<b>SCENE BEING PHOTOGRAPHED:</b>	Paint Filters
<b>SITE LOCATION:</b>	300 Highway 361 Crane, Indiana
<b>INSTALLATION NAME:</b>	Crane Naval Surface Warfare Center
<b>INSTALLATION I.D. #</b>	IN5 170 023 498

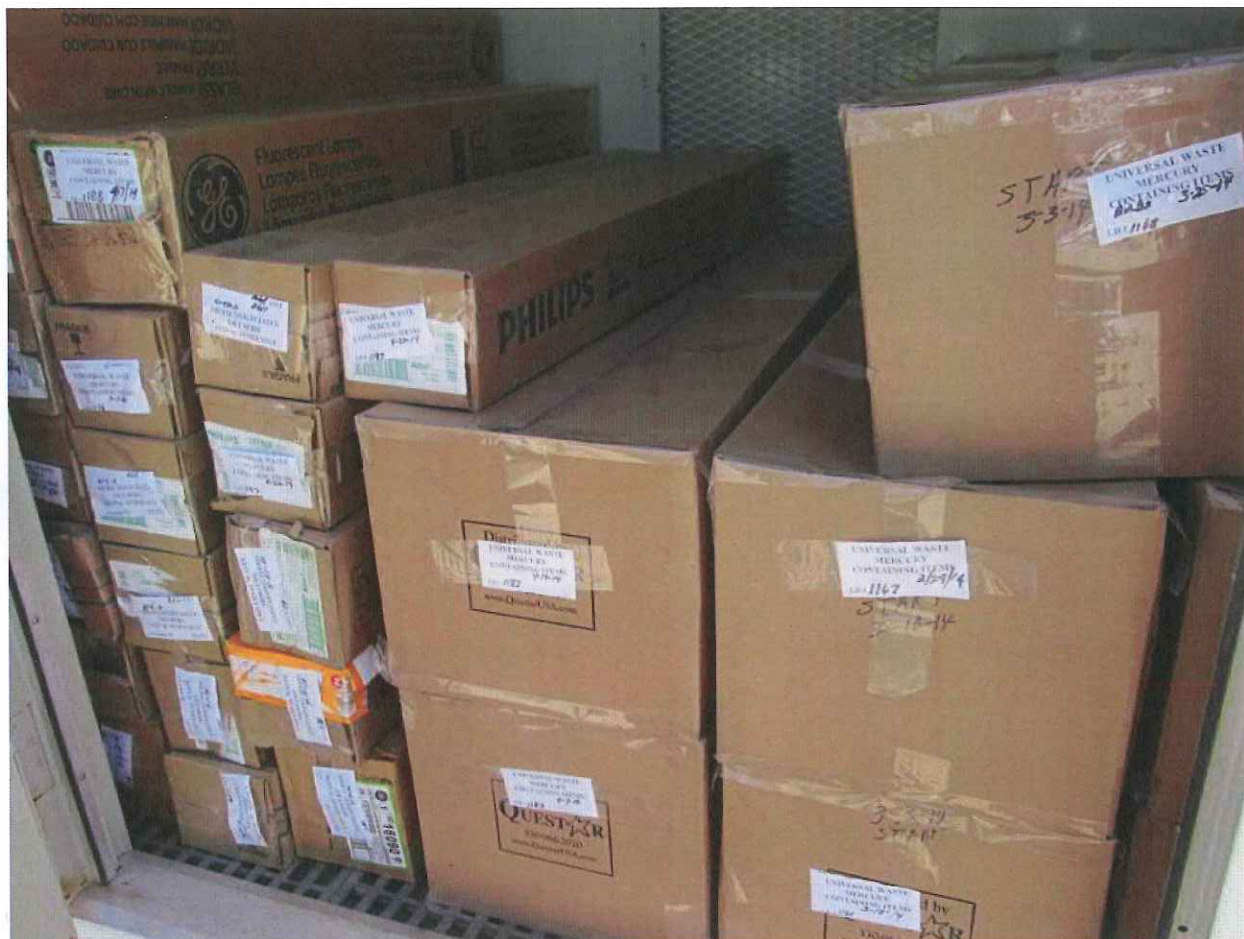
**PHOTOGRAPH #29**

- There were closed/labeled waste lamps and waste batteries in the respiratory area. I also observed one unlabeled 55-gallon drum of used oil being stored in a cornex box (shed type structure) Photographs 28 through 38.

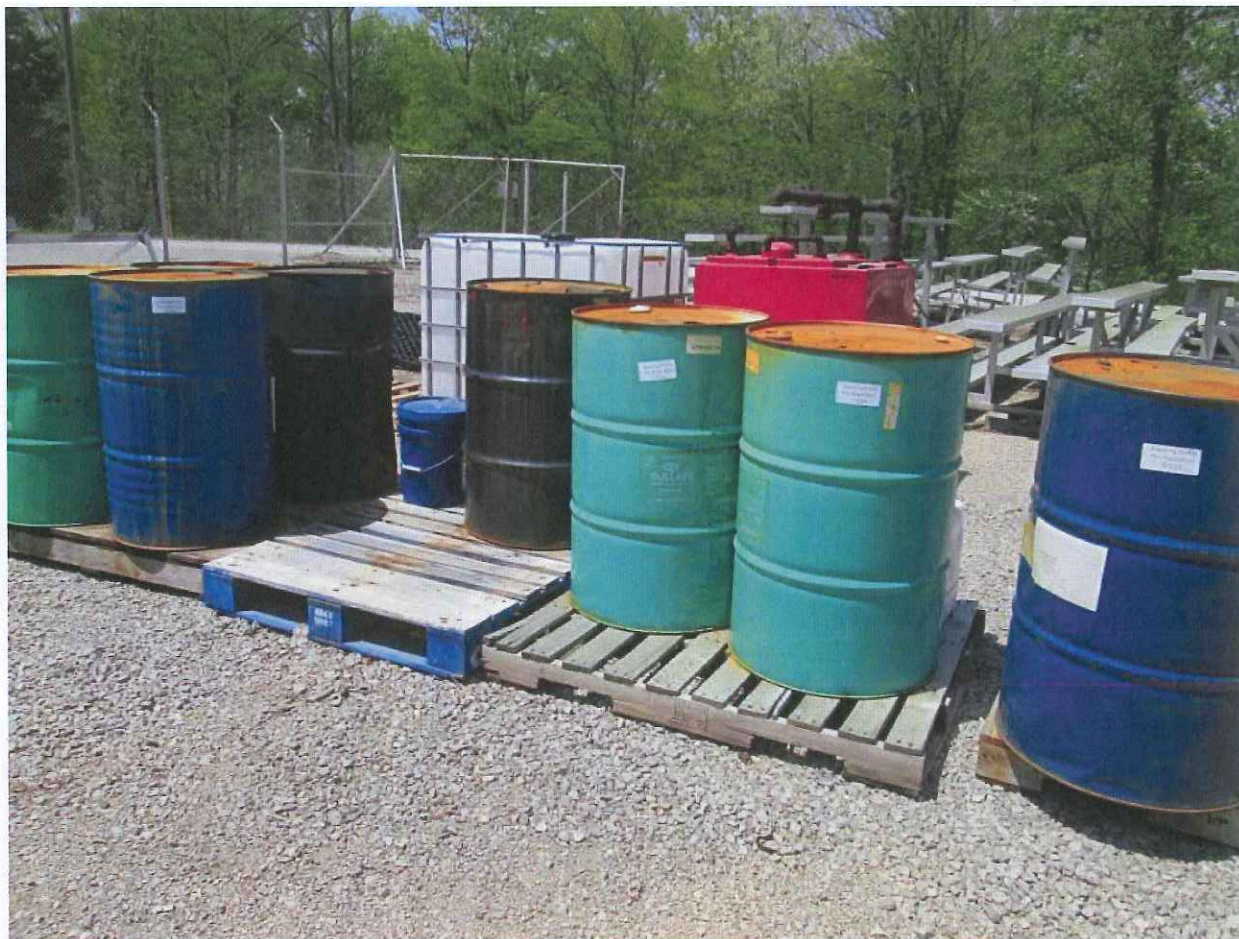
**PHOTOGRAPH #39**

At the time of the May 6 through 8, 2014 inspection, CNSWC had not made the required waste determinations on 15 containers of waste located outdoors near the respiratory area. CNSWC, therefore, violated the hazardous waste determination requirement.

- There were 15 unlabeled hazardous waste containers ranging in size from 55-gallons, 5-gallons and 3-gallons. There was also one unlabeled red 500-gallon tank in the respiratory area. Waste determination had not been performed on any of waste in those containers and tank (Photographs 39 through 41).

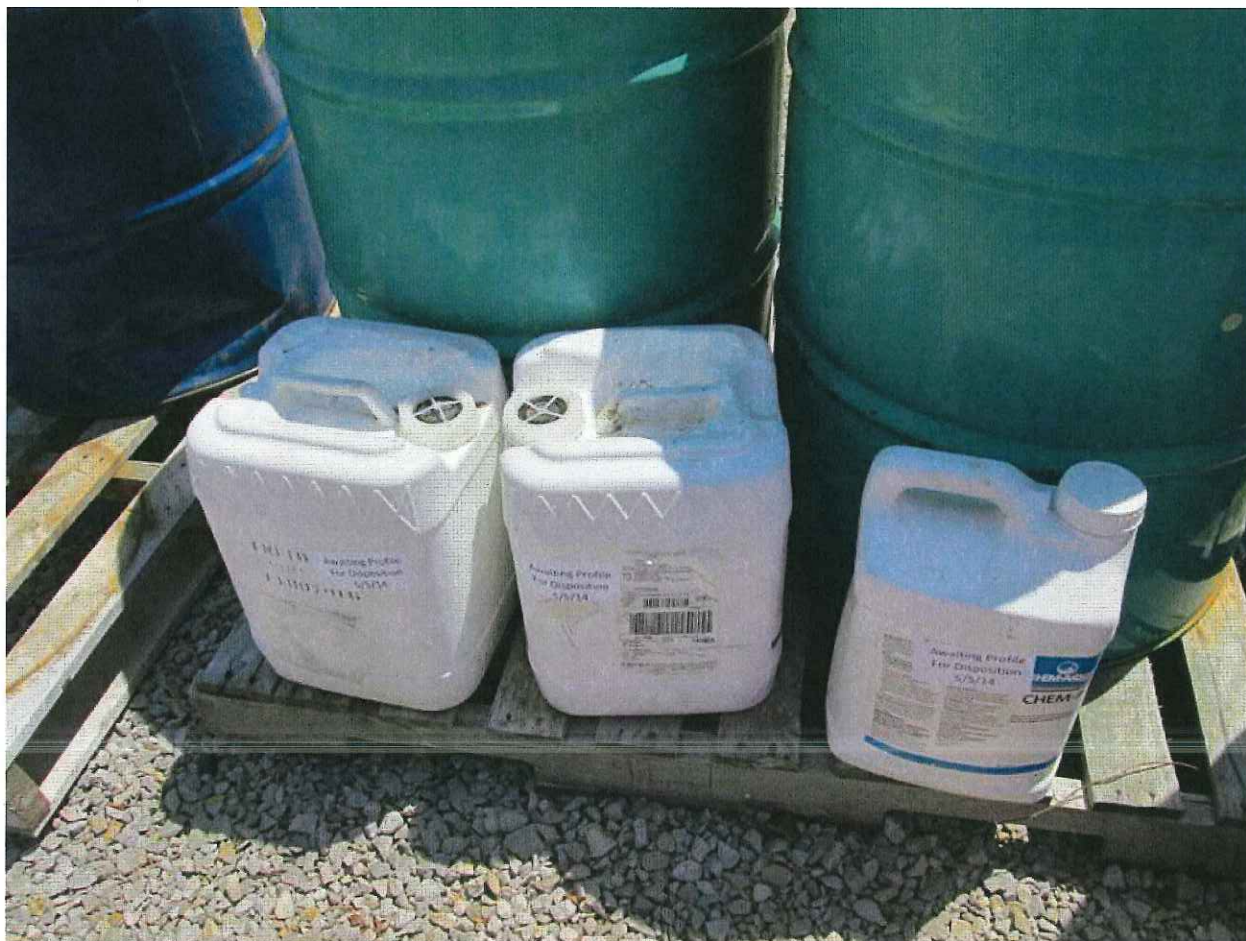
**PHOTOGRAPH #40**

<b>NAME OF PHOTOGRAPHER:</b>	Sheila Burrus
<b>DATE OF PHOTOGRAPH:</b>	May 7, 2014
<b>LOCATION OF PHOTOGRAPH:</b>	Repository Area
<b>SCENE BEING PHOTOGRAPHED:</b>	unidentified waste containers
<b>SITE LOCATION:</b>	300 Highway 361 Crane, Indiana
<b>INSTALLATION NAME:</b>	Crane Naval Surface Warfare Center
<b>INSTALLATION I.D. #</b>	IN5 170 023 498

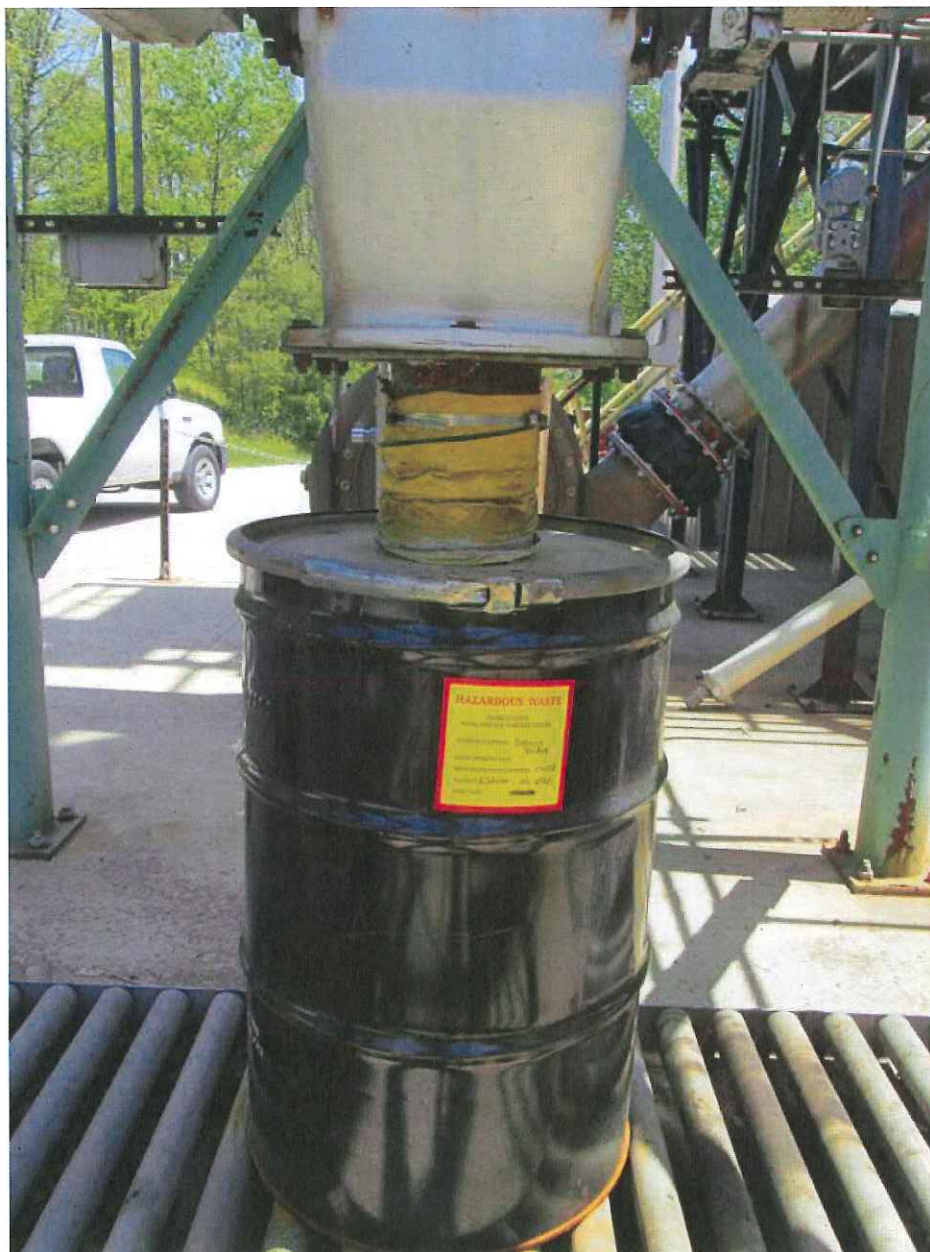
PHOTOGRAPH #43

- There was one closed/labeled 55-gallon satellite accumulation container of hazardous waste baghouse dust and one 55-gallon satellite accumulation container of cyclone separator residue outside of building 3343 (Photographs 43 and 44) .

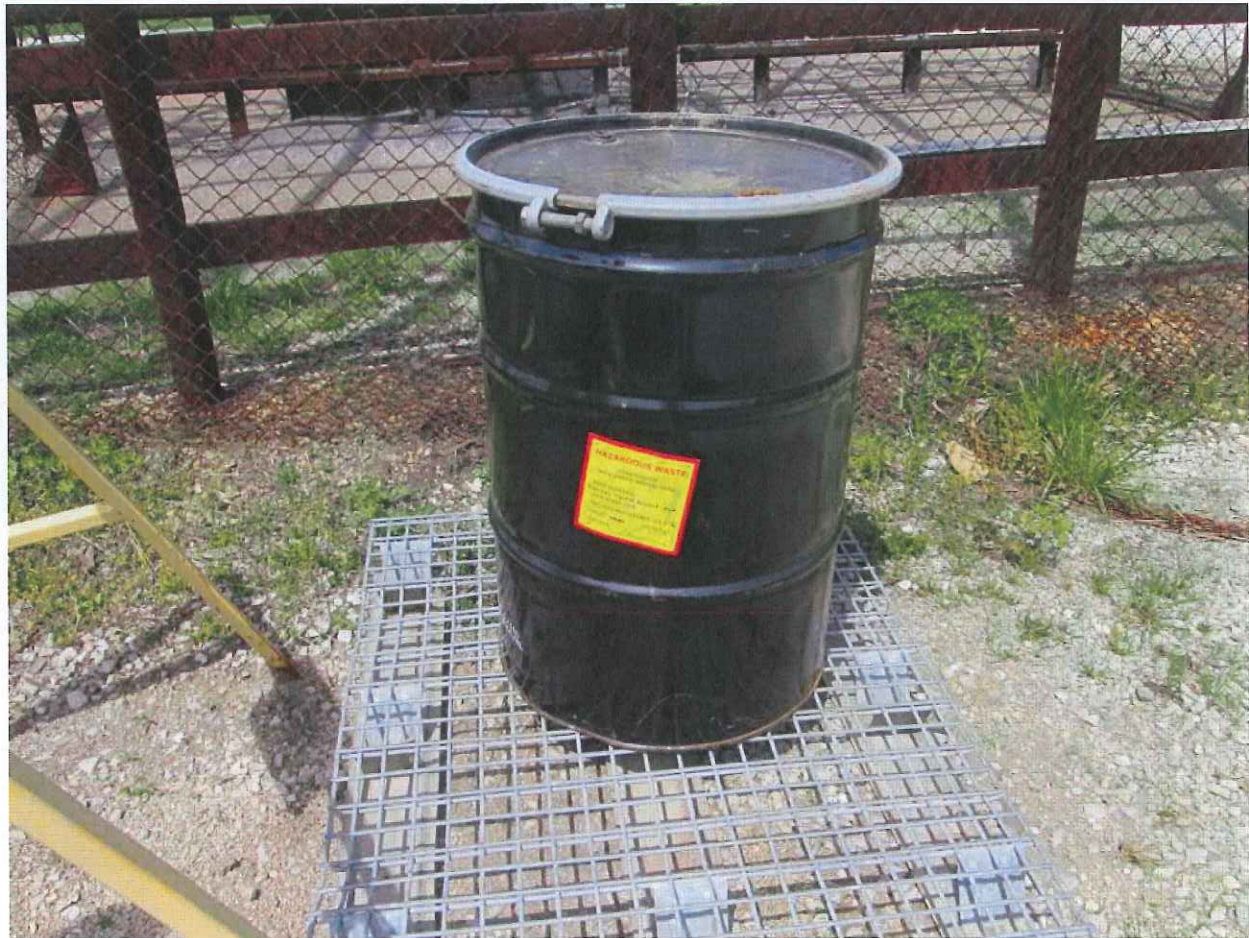
**PHOTOGRAPH #45**

- There was one closed/labeled 55-gallon satellite accumulation drum of explosive contaminated solvent and one emptied roll-off box at the Ammunition Burning Ground (Photographs 45 and 46).

<b>NAME OF PHOTOGRAPHER:</b>	Sheila Burrus
<b>DATE OF PHOTOGRAPH:</b>	May 7, 2014
<b>LOCATION OF PHOTOGRAPH:</b>	Ammunition Burning Ground
<b>SCENE BEING PHOTOGRAPHED:</b>	55-gallon drum of Thermal Treated Solvent Ash
<b>SITE LOCATION:</b>	300 Highway 361 Crane, Indiana
<b>INSTALLATION NAME:</b>	Crane Naval Surface Warfare Center
<b>INSTALLATION I.D. #</b>	IN5 170 023 498

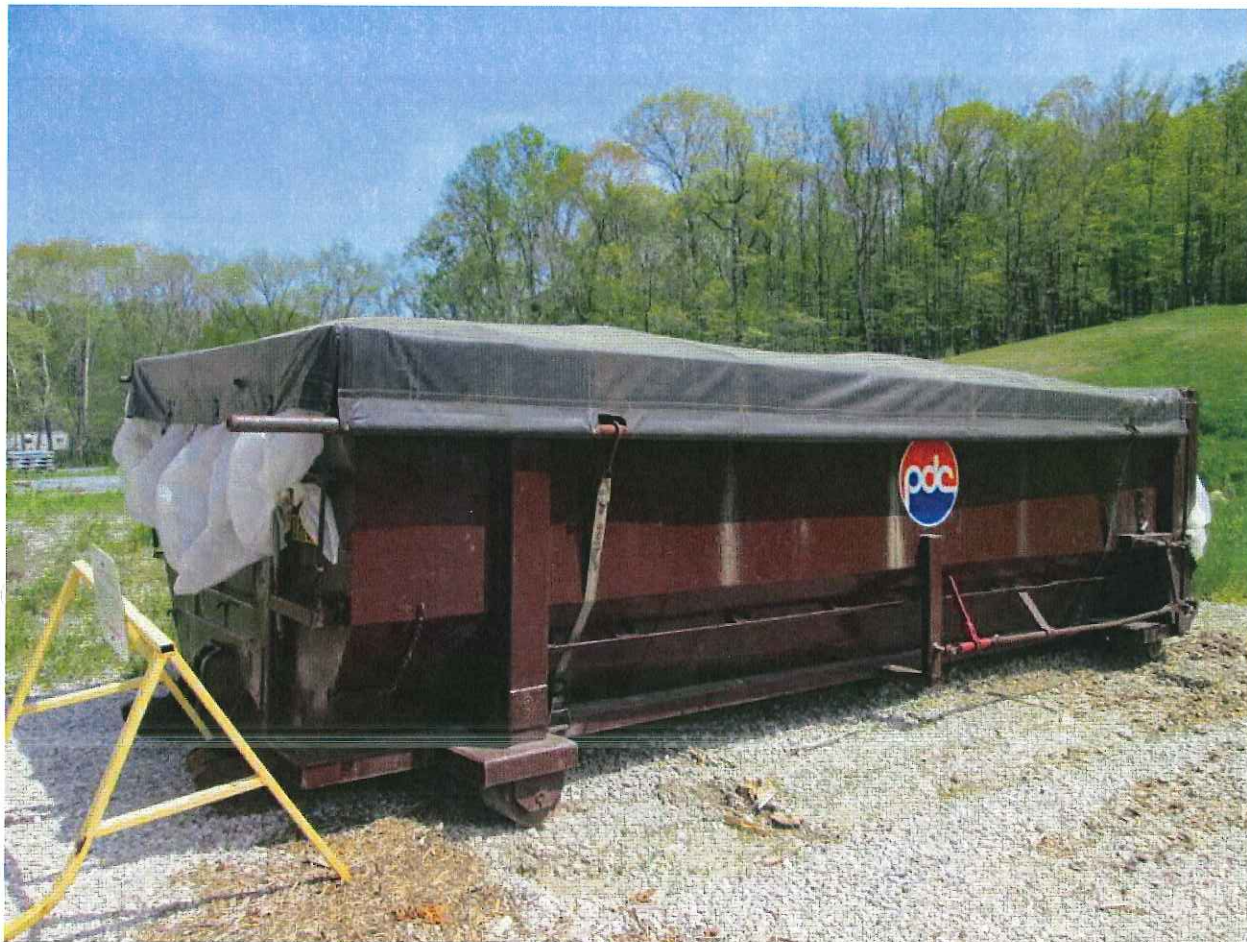
**PHOTOGRAPH #46**

emptied hazardous waste roll-off box

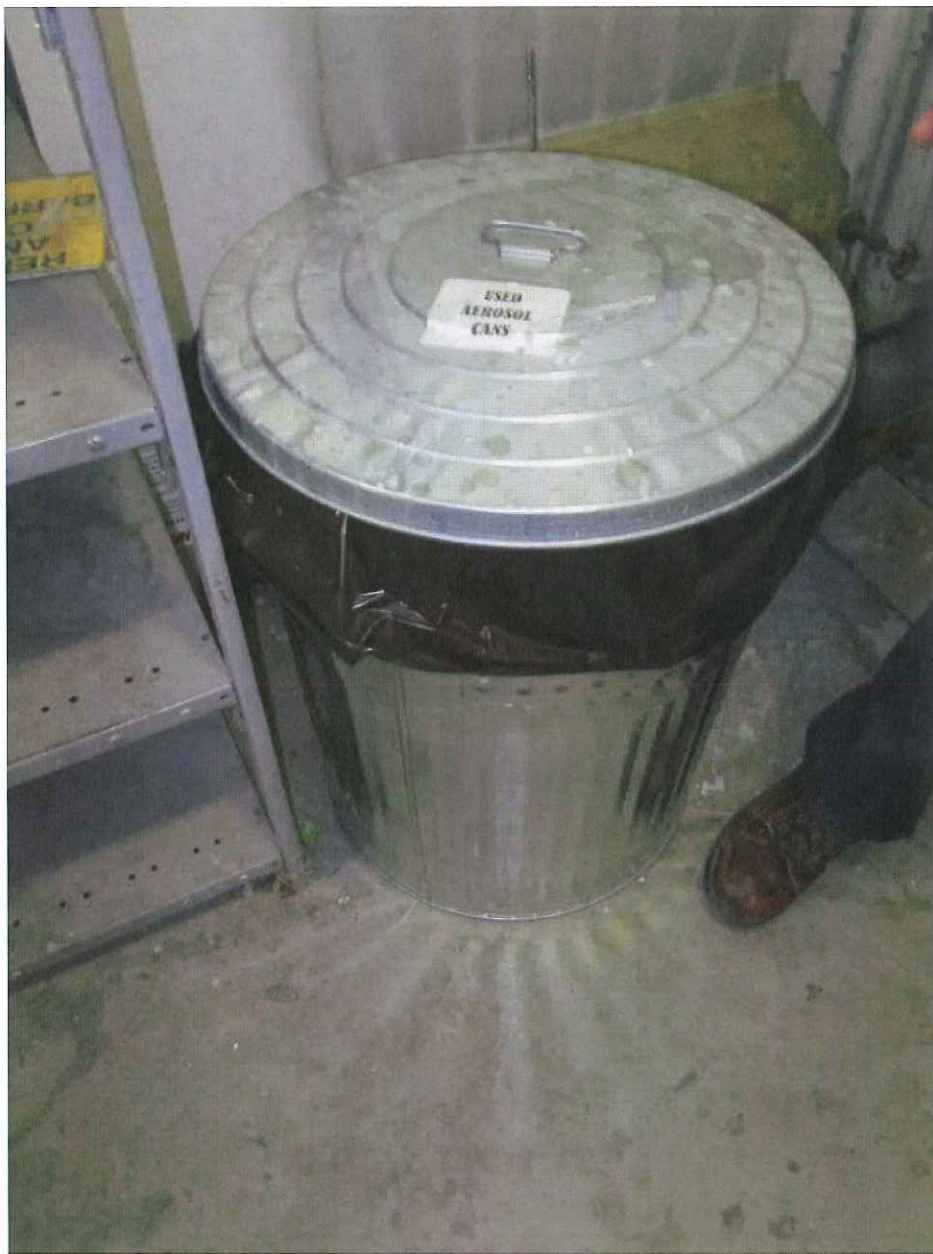
**PHOTOGRAPH #49**

- There was one closed/labeled 30-gallon container of used aerosol in building 3234-Site A (Photograph 49).
- There was one closed/labeled 55-gallon container of chromium/cadmium sludge on the conversion coating line (Photograph 50).

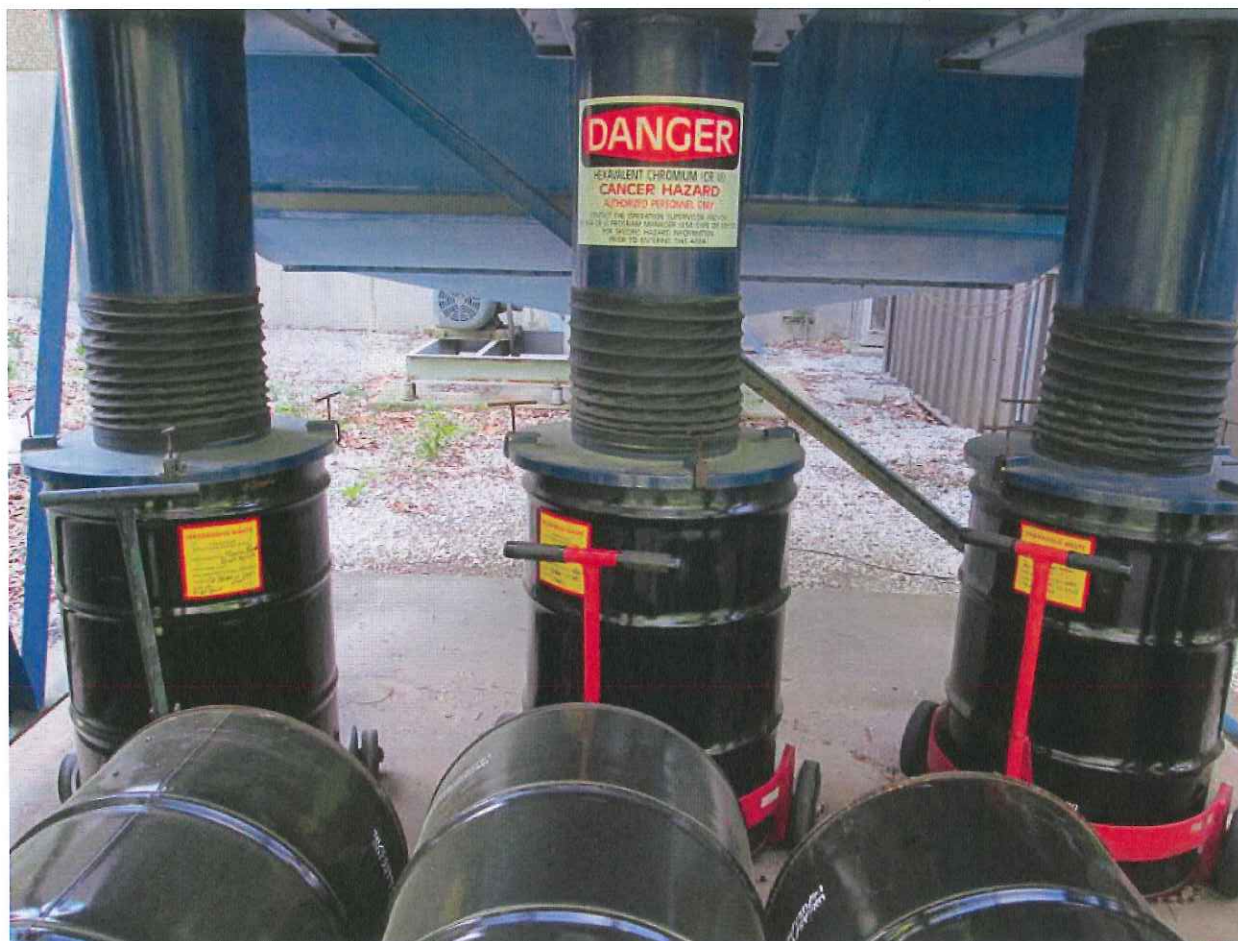
PHOTOGRAPH #51

- There were three closed/labeled 55-gallon hazardous waste drums of plastic bead media building 3234-Site C less than 90-day hazardous waste storage area (Photograph 51).

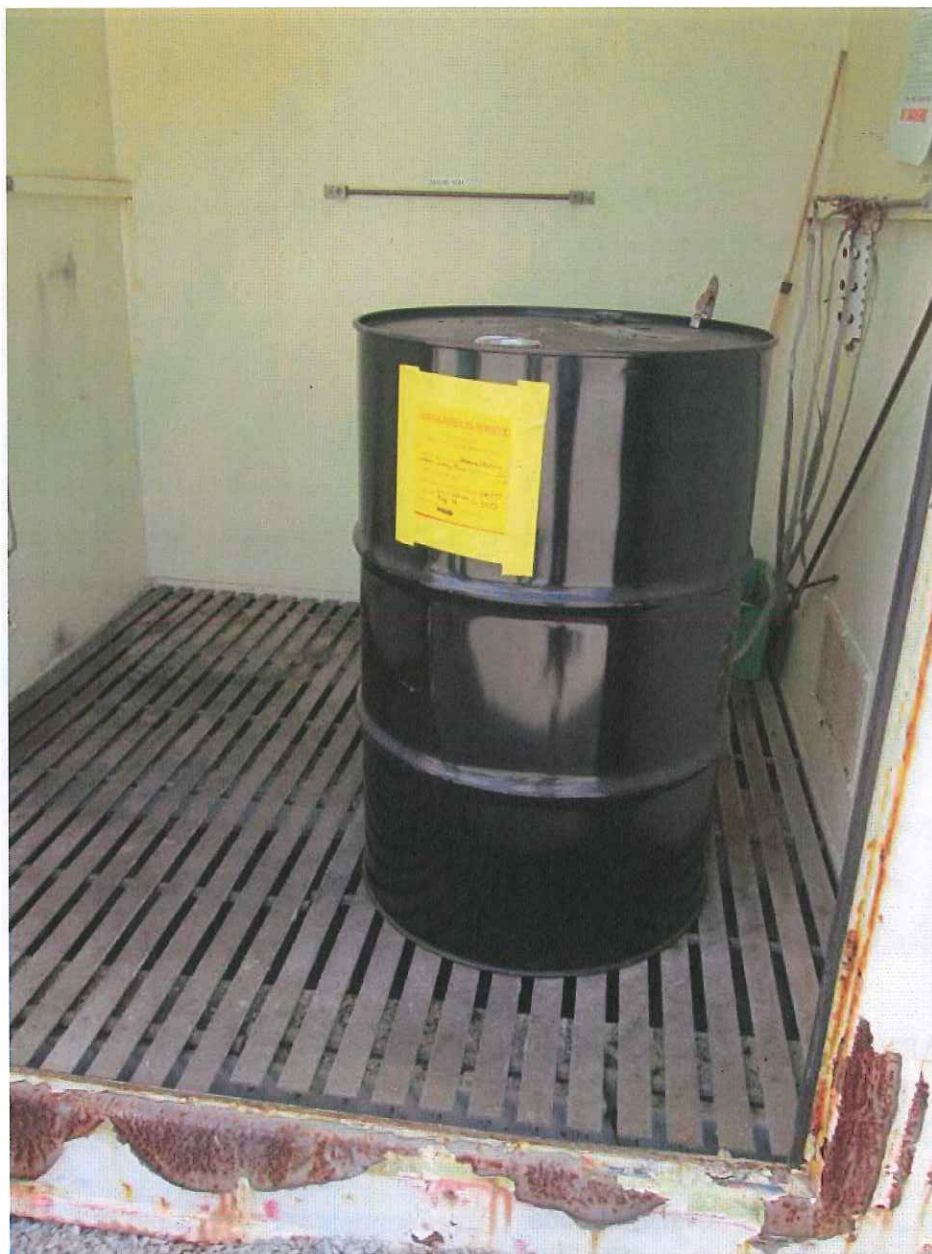
**PHOTOGRAPH #57**

- There was one closed/labeled 55-gallon satellite accumulation drum of hexane/acetone solvent waste in building 198 non-explosive hazardous waste storage area (Photograph 57).
